**KOKUYO CO., LTD. (Nagoya Distribution Center)  
 SUPER THERM applied to Batten Seam Roofing  
 Application Year: 1994 Application Area: 6,000sqm**

**SPI CASE HISTORY**

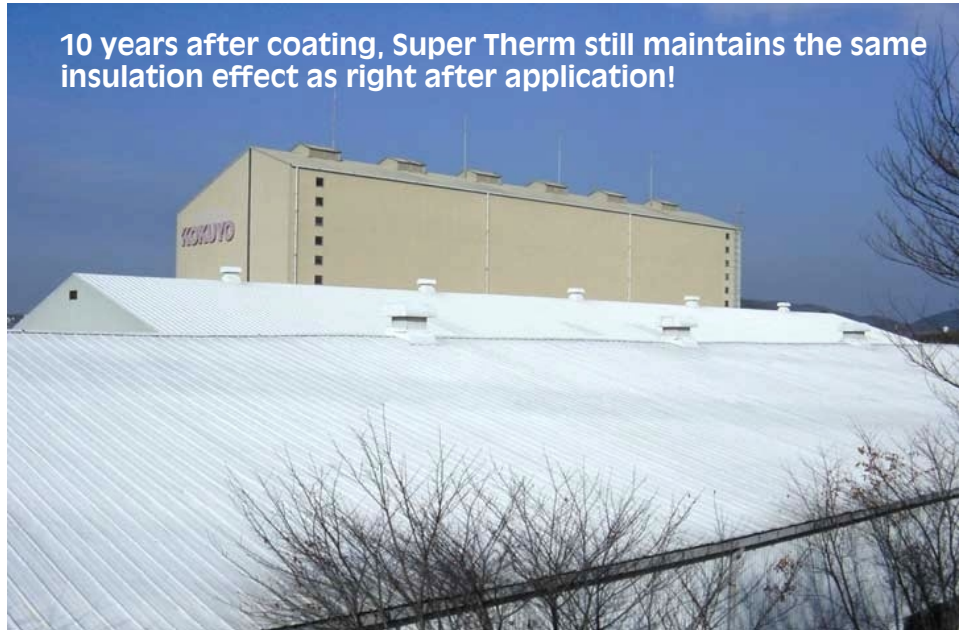
When SUPER THERM was applied in 1994, the room temperature had decreased by 5 to 7°C, and it was kept below the outside temperature.

The coating maintained the same insulation effect in 2004, a full 10 years after it was applied!

**Temperature Result  
 Measurement Points: 1.8m from the floor of the second-floor**

Date	Weather	Room Temperature	Outside Temperature
<b>Before</b>	July 9, 1997	Clear	37C	30.4C
	July 10, 1994	Fine	39C	33.5C
<b>After</b>	July 30, 1994	Cloudy	32C	32.5C
	July 31, 1994	Clear	34C	35C
<b>After 10 Years</b>	August 27, 2004	Clear/Cloudy	33.8C	33.1C
	August 28, 2004	Cloudy/Clear	33.5C	34.3C
