Coatings Solutions and SPI Solve a Major Heat and Maintenance Problem for Liberty County

During July of 2009, Coatings Solutions was engaged to coat the roof of the Liberty County Precinct 4 Maintenance Barn.

SPI CASE HISTORY

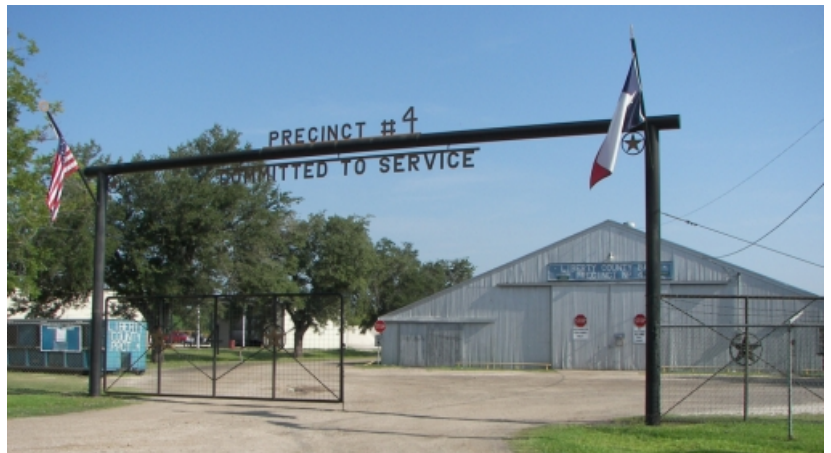
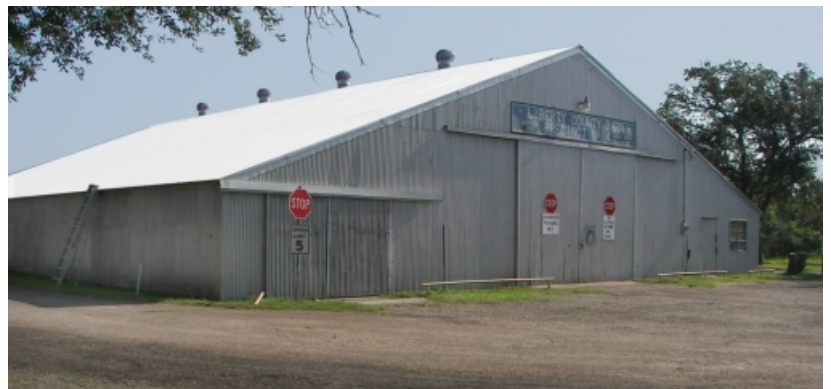
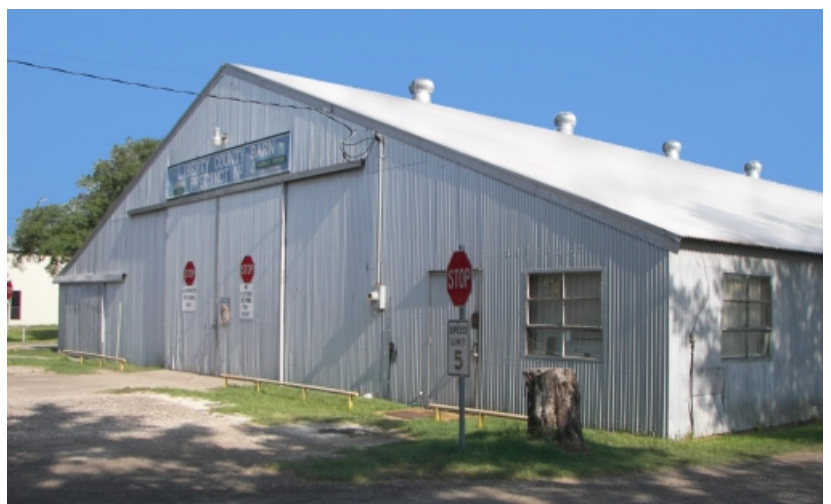
The building is over 50 years old. It is made of corrugated sheet metal over a tubular framework. The overall dimensions of the roof are 100 x 80 feet.

During the 50 years, Liberty County has never been able to find a workable or practical solution to dealing with the heat buildup. Over the many years, the roof started rusting and many of the hold down fasteners loosened. Plus, there were 18 fiberglass skylights that were exhausted and needed to be replaced with sheet metal.

The job took Coatings Solutions four days to accomplish. First, the entire roof was inspected and then power washed. The fasteners were secured, skylights covered and the coating of Rust Grip was applied. Next, the seams were taped, and then primed with SuperBase. Finally, the Super Therm was applied to complete the entire process.
